MORGAN BRIDGE

HAER VT-33

MORGAN BRIDGE HAER No. VT-33

Description¹

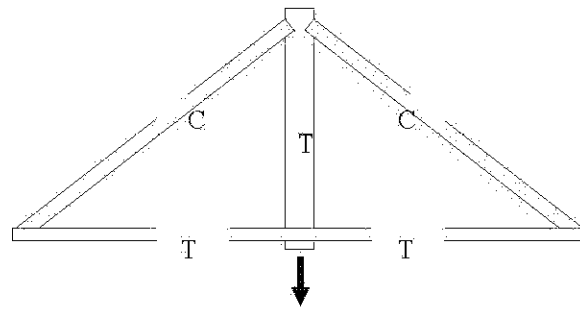
Figure 1. Typical kingpost configuration

Nevertheless, this study of the most basic truss forms should prove valuable, since they established many of the principles that made the more-complex designs possible. These two forms date back to at least the sixteenth century. The kingpost is unarguably the simpler form of the two, consisting of a bottom chord, a center vertical member (the kingpost) and two diagonal bracing members that extend from the top of the kingpost to the ends of the bottom chord. The bottom chord and kingpost act in tension, and the diagonal braces are in compression under typical loading conditions. The forces in the structural members are illustrated in Figure 1, where compression members are labeled “C,” and tension members are labeled “T.”

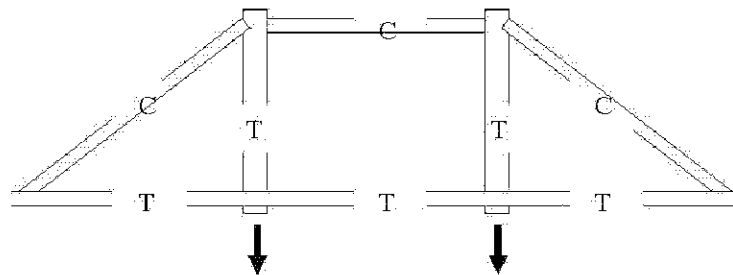
The queenpost is a variation of the kingpost form that was most likely developed to span longer distances. The queenpost form contains three panels, separated by two vertical tension members (queenposts). As in the kingpost, the bottom chord is under tension and the diagonals are in compression, as shown in Figure 2. The center panel, between the two queenposts, is an open box formed with the top and bottom chords. Having no diagonal braces, it would be unstable, except that the truss must have an effectively continuous bottom chord capable of resisting moment loads at the bottom of the queenposts.

Figure 2. Typical queenpost configuration

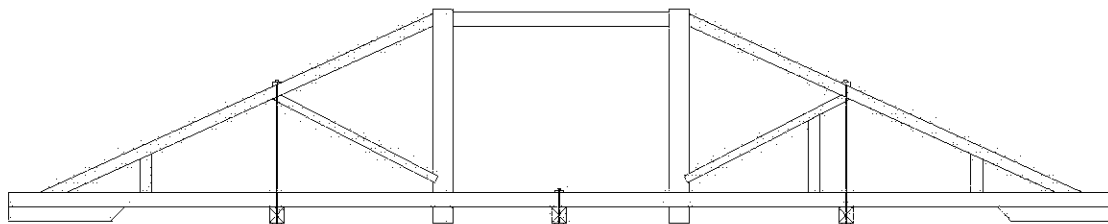
to transfer loads from the deck to the truss. Metal rods in the side panels doubled as tension members (posts) in the truss and as a means to transfer load from the floor beams. Since the bridge had no post at its center, short rods were used to connect the floor beam to the lower chords at mid-span. For reasons lost to time, an odd post was inserted in the north side panel, but not quite at the intersection of the two diagonal members. The south side panel had no counterpart.

Figure 3. 1899 Configuration of the Morgan Bridge

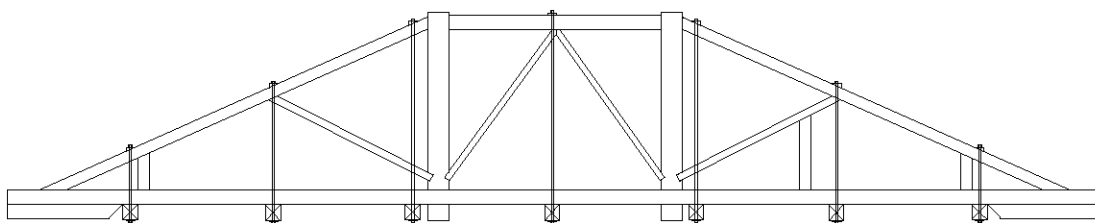
In 1979, the Vermont Agency of Transportation rehabilitated the Morgan Bridge to the configuration illustrated in Figure 4. Four floor beams were added to bring the total to seven, and as in the original construction, metal rods were used to attach the new floor beams to the truss. It appears that the engineers' primary concern at the time was the floor, rather than the truss itself. Except for the addition of diagonals in the center panel to create a new panel point for the center floor beam support rod, there is no indication that individual truss members were strengthened. One area of particular interest is whether these new diagonals significantly altered the truss's performance.

Figure 4. Current (post-1979) Configuration of Morgan Bridge

In addition to capturing the varying joint stiffnesses between members, an attempt was also made to capture any significant eccentricities that might affect the structural behavior of the bridge. One of these eccentricities was at the connection between the new (1979) bracing in the center panel and the original top chord. The eccentricity of this connection can be seen in Figures 4, 14, and 16.

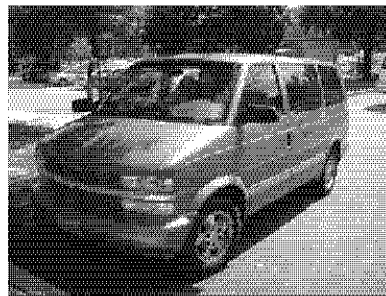
The vehicle used to load test the Morgan Bridge was a Chevrolet Astro Van. Figure 5 is a photograph of the vehicle and Figure 6 illustrates the assumed axle weights, based on the curb weight data obtained from the manufacturer's specifications.

Figure 5. Chevrolet Astro van used in experimental load testing

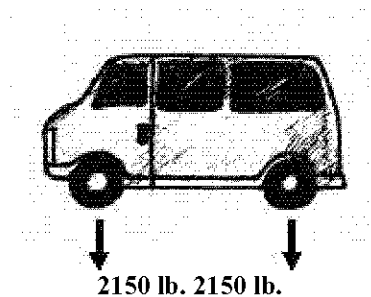
Figure 6. Assumed axle weights of load test vehicle

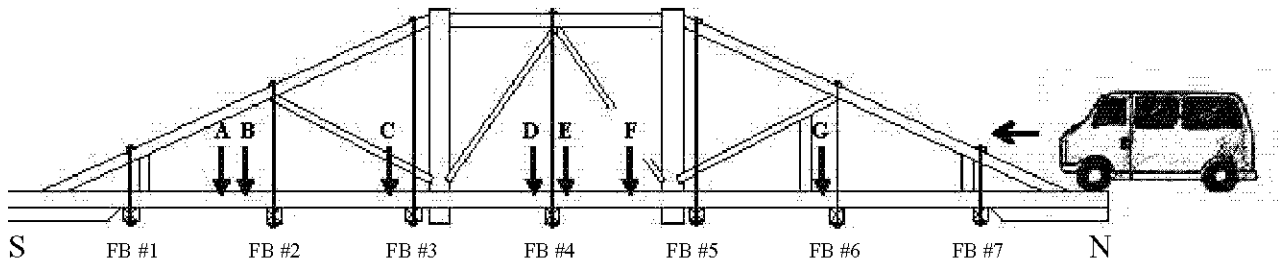
Instrumentation used to measure the bridge's response to live loading was placed on the bridge prior to testing. The truck was driven across the bridge from north to south several times, stopping at predetermined locations along the span so that data could be recorded from the instrumentation. These selected stopping points were chosen based on preliminary computer modeling done prior to field work. Tape was used to mark the exact axle locations during the first run of the truck across the bridge so that the same locations could accurately be found in each subsequent run. The arrows in Figure 7 indicate the locations at which data were recorded.

Figure 7. Typical front axle locations along the west truss (view from inside bridge)

Twelve trials were performed for each rod: three with the truck at location C, six at D, and three at location G (see Figure 7). The results of the data collected from the strain gages are shown in Table 5. A positive strain indicates axial tension, and a negative strain indicates compression. Strain gage data was read in microstrains from a strain indicator unit that was connected to all three strain gages.

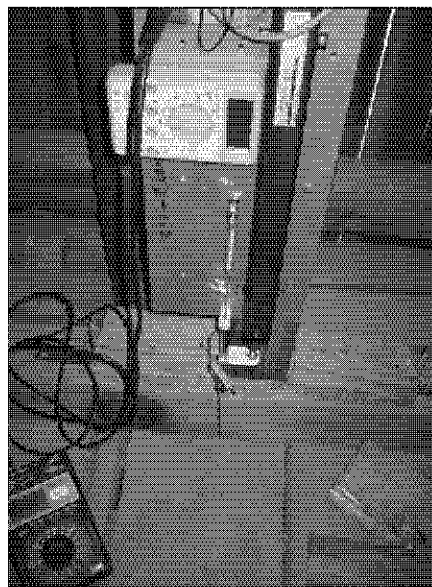
An LVDT may be used to measure the relative movement between any two points. Using an LVDT alone is somewhat limiting in fieldwork, so a linear spring-cable system was introduced to the assembly. The cable allowed measurements between two points spaced far apart, and the spring allowed the LVDT to capture both positive and negative movements. The LVDT assembly shown in Figure 8 had one end attached to the bridge at mid-span and other end fixed to a point in the stream bottom.

Figure 8. Linear variable differential transformer (LVDT) assembly

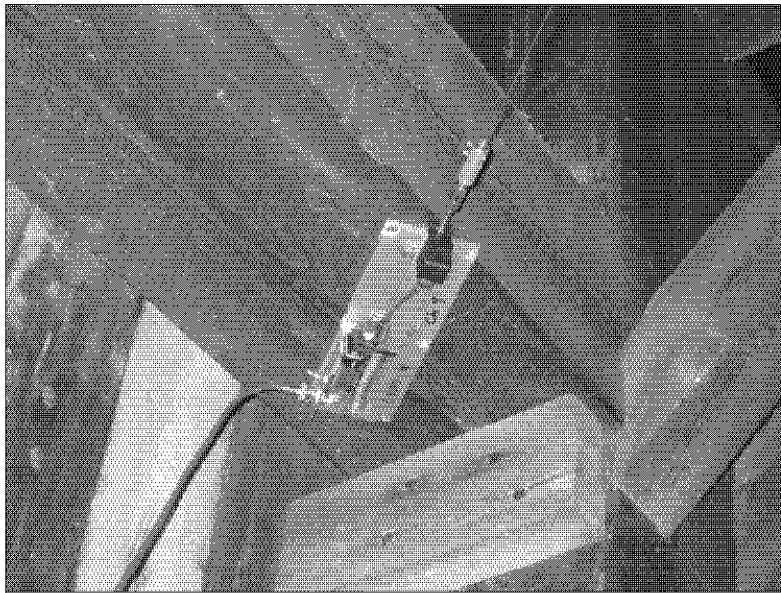
Two Position Transducers were used in the load-testing program. Their assembly also employed a linear spring-cable assembly similar to that used with the LVDT, as shown in Figure 9. The difference in the two assemblies is that the position transducers capture relative movement through a different mechanism than the LVDT. Additionally, the position transducer's range of motion is only 4 centimeters, as opposed to 6 centimeters for the LVDT used. In Figure 9, the position transducer is mounted underneath the top chord of the west truss, adjacent to the north queenpost, and the cable runs diagonally to a position on the east truss, adjacent to the south queenpost. This was done to examine out-of-plane effects of live loading on the bridge.

Figure 9. Position transducer assembly

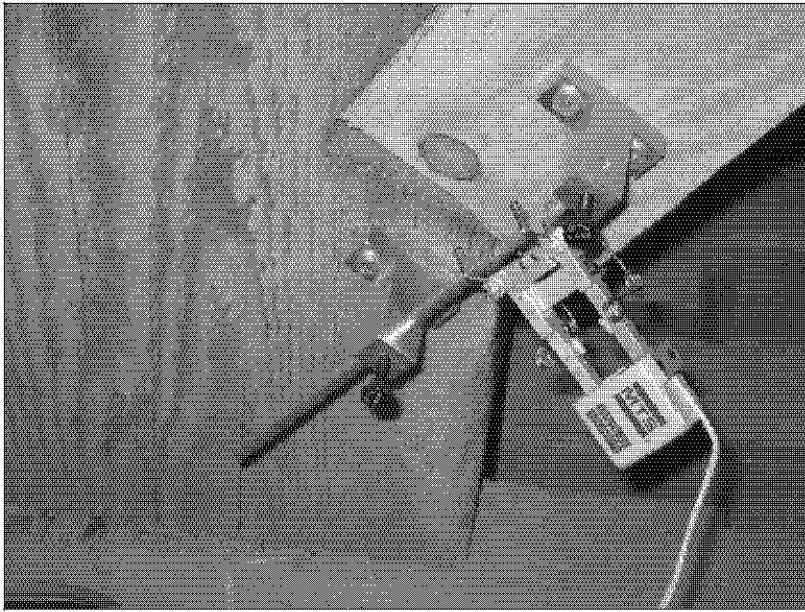
An extensometer also measures the relative movement between two points. It is a small instrument with only a 1/4-inch range of motion, but it is highly accurate and a good instrument for measuring movements across connections. For these tests, an extensometer was mounted at the connection between one of the new diagonal members in the center panel and a queenpost, as shown in Figure 10.

Figure 10. Extensometer spanning the joint between a diagonal and queen post

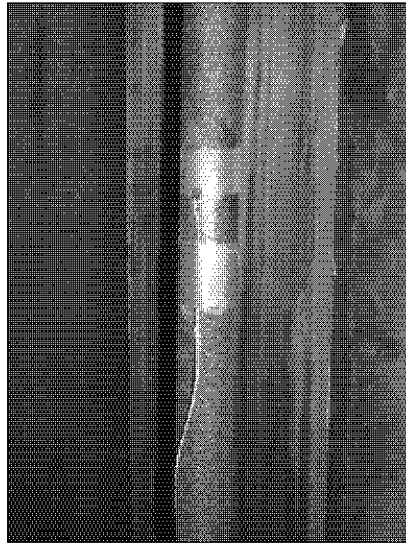
Strain gages were used to measure the axial strain in bridge members when subjected to live loading. While it is possible to mount them to wood members, they are more accurate when mounted to metal. Figure 11 shows one of the strain gages mounted to a metal rod. The gages used were capable of capturing up to 5 percent strain.

Figure 11. Strain gage mounted to a metal rod on the west truss

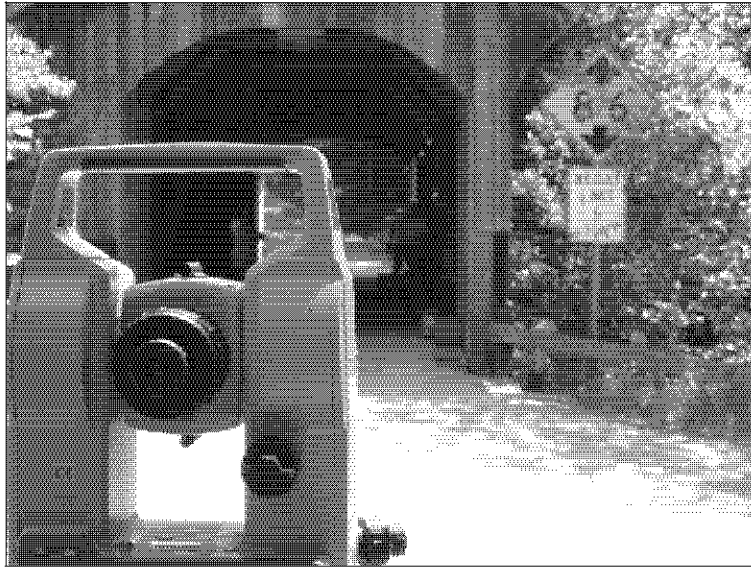
Surveying equipment, normally used for land surveying, was used to collect overall deflection data. The equipment included a total station and several reflective prism targets.

These are shown in Figures 12 and 13, respectively. Prisms were securely attached to the structure using custom-built brackets, and their initial positions were measured and recorded by the total station. These positions corresponded to the bridge in its dead load condition. The positions of these prisms were again measured and recorded by the total station under the various live load conditions to allow calculation of the deflection at each target location.

Figure 12. View of total station with respect to the bridge

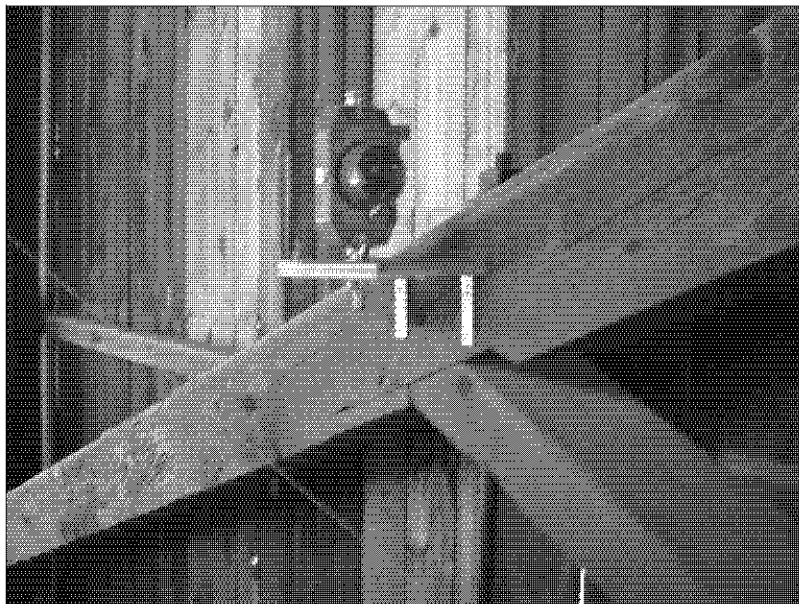
Figure 13. Typical reflective prism target and bracket

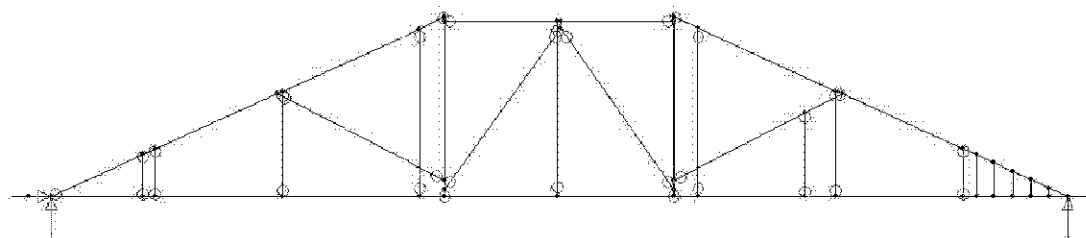
Based on information collected in the field, a computer model of the Morgan Bridge truss was developed using the MASTAN2 structural analysis software.²² A three-dimensional model will be presented briefly later in the report, but a majority of the analysis, both in the field and using the model, was performed in two dimensions, and on the west truss alone. Since the two trusses appeared to be alike, it was believed that they would perform the same way.

Figure 14. Single-line diagram of west truss model

As the diagram in Figure 14 shows, the model of the bridge used had forty-six nodes connecting sixty-six beam elements. The elements represent the centerlines of the actual member dimensions, as measured in the field. While a typical truss model assumes pinned connections at all nodes, in this case only the ends of certain members are pinned, while others are modeled as fixed connections. A fixed connection allows the transfer of moment between members, but a pinned connection is capable of transferring only axial forces. The circles shown in the model indicate the connections modeled as pins. (The actual bridge has fixed connections wherever a member, such as the top or bottom chord, is continuous across a connection, but there is limited rotational flexibility between the chords and the posts, so pin connections were used.) One location where all members were modeled as fixed was at the north (right) end of the west truss, where a triangular metal plate is securely fastened between the bottom chord and top diagonal bracing. The plate was modeled as a series of vertical steel elements, fixed at the top and bottom where they connected to the timber truss members. This plate can be seen in the Figure 15 below.

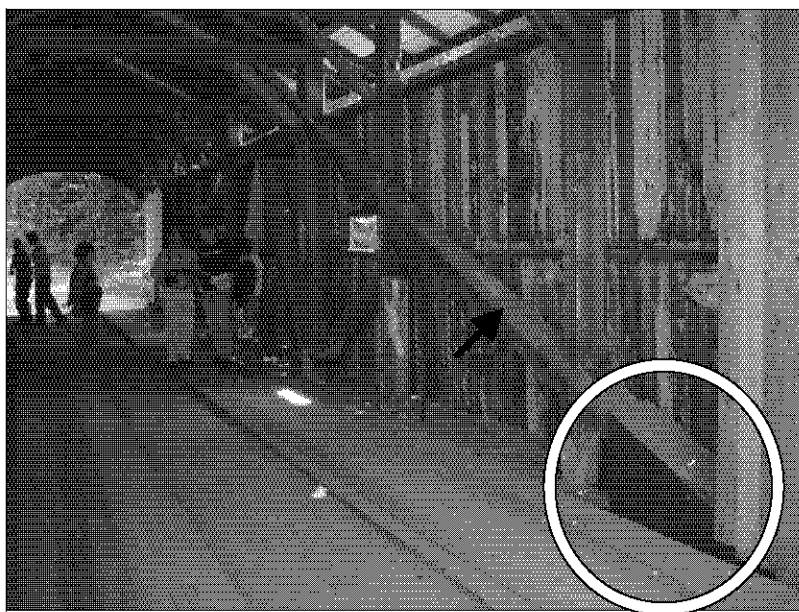
Figure 15. Triangular metal plate in northwest corner of west truss

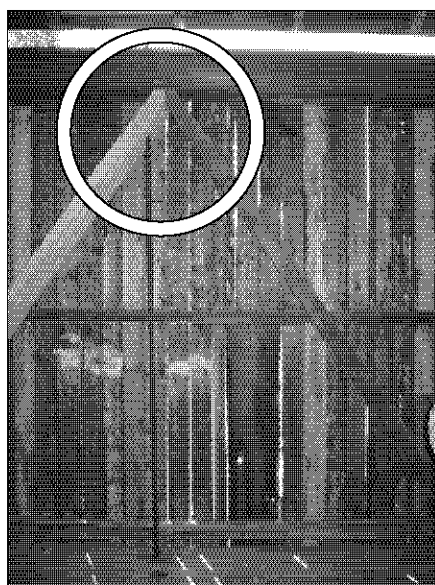
Figure 16. Eccentricity of connection at mid-span of top chord.

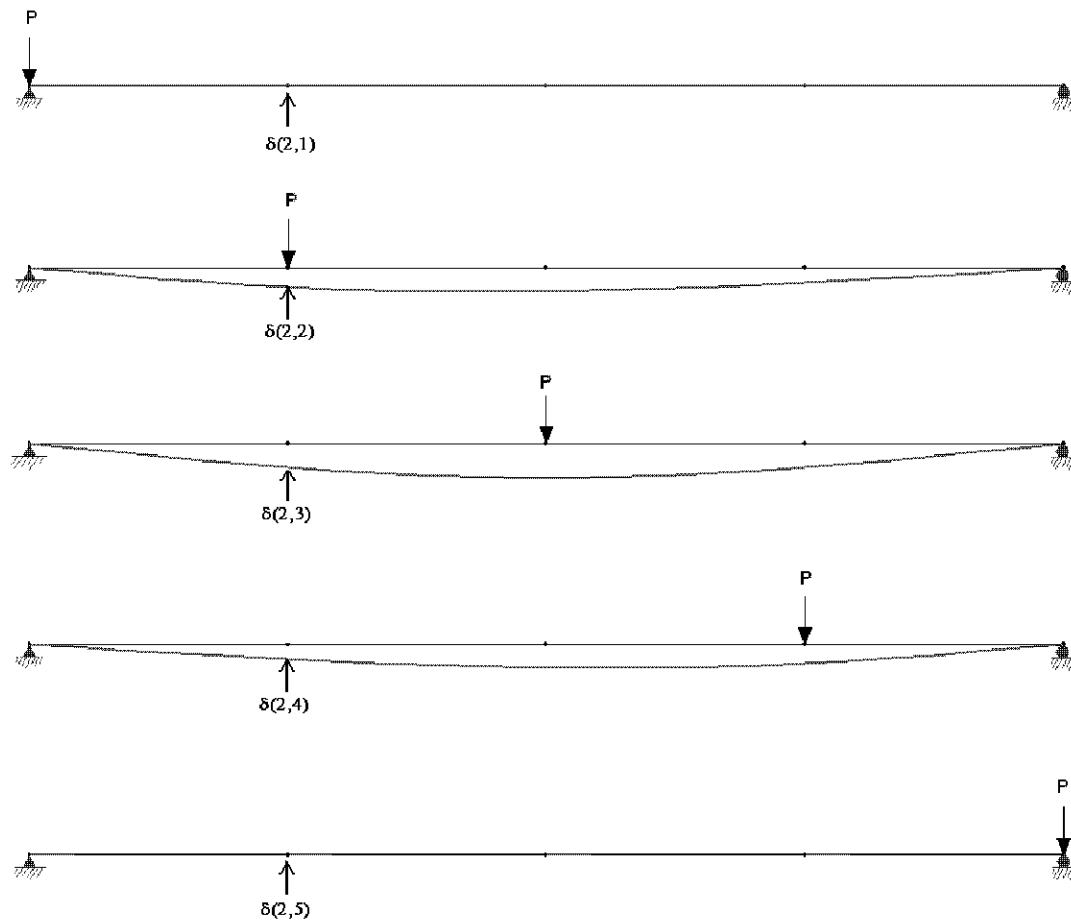
Figures 19 and 20 form an elementary example showing the influence line of quarter-point deflection on a simply supported span.

Figure 19. Series of loading conditions on one beam used to develop an influence line

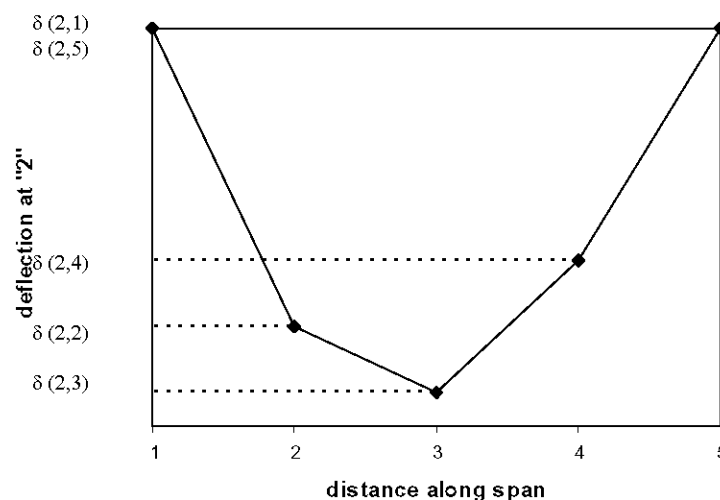
Figure 20. Influence line for quarter point deflection of a beam with simple supports

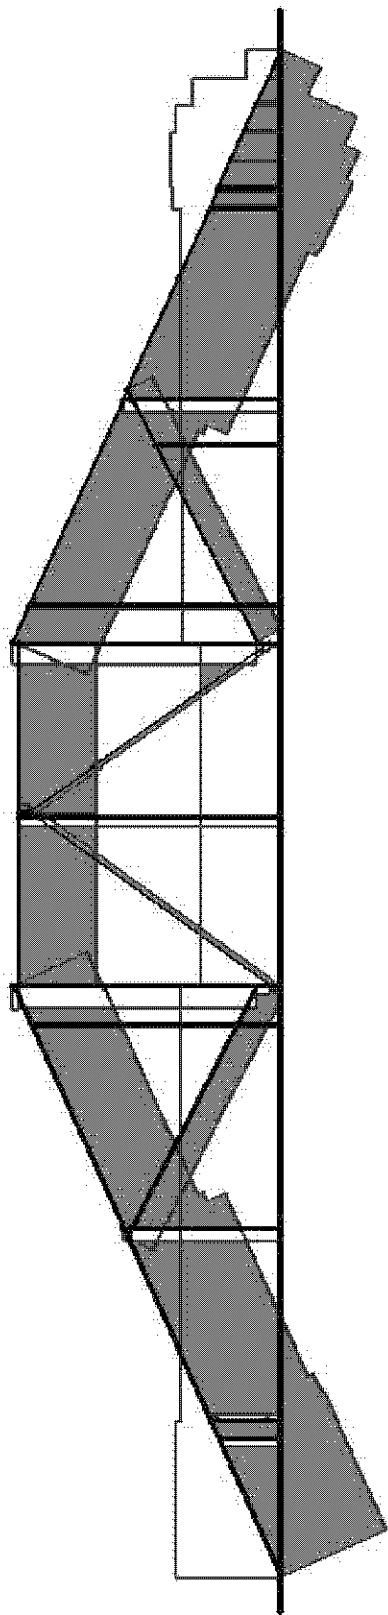
Figures 21 and 22 show the axial force diagrams for the existing and original configurations, respectively. The thickness of each member in these diagrams is indicative of its stress, with the shaded members in compression and the unshaded ones in tension. While the diagrams are not labeled for simplicity, they are drawn to the same scale. The compression forces in the top chord and tension forces in the bottom chord are similar for both configurations. Specifically, the maximum compression in the top chord is approximately 15,200 pounds for the existing configuration (Figure 21) and 12,500 pounds for the original configuration (Figure 22). The maximum tension in the bottom chord is 14,000 pounds for the existing configuration and 11,300 pounds for the original configuration. The forces due to dead loads in the existing configuration are approximately 20 percent higher than those in the original configuration, which is due to the addition of four floor beams in 1979, as well as the significant change in the floor system load distribution that resulted from this change. Prior to the rehabilitation, the bolster beams likely distributed more load from the floor system to the abutments, but with addition of floor beams so close to the bolster beams, their role has likely been reduced significantly. The forces in both configurations are typical for the queenpost form, with only the bottom chord and queenposts in tension (plus the floor beam hanger rods in the existing configuration).

Figure 22. Axial Forces Caused by Dead Loads in Existing Configuration

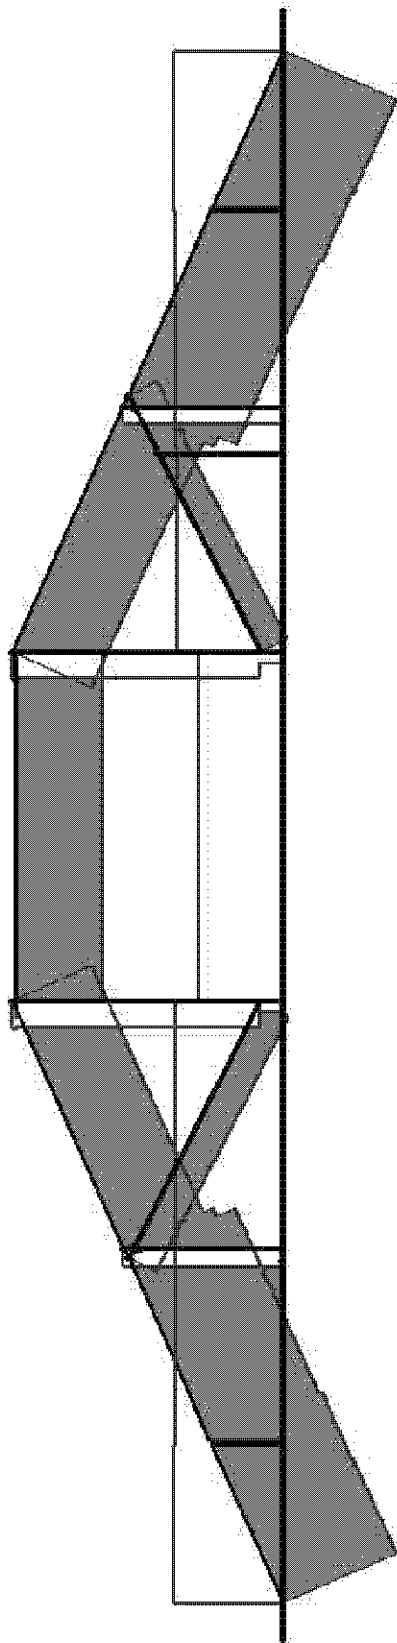
Figure 23. Axial Forces Caused by Dead Loads in Original Configuration

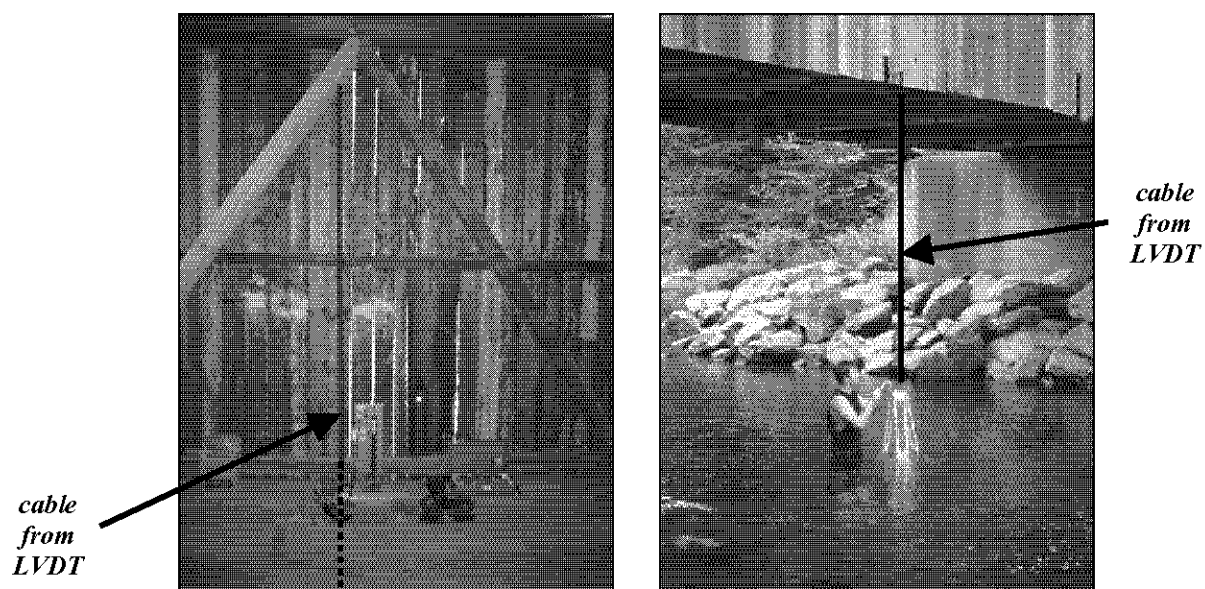
Figure 23. Measuring mid-span bridge deflections with LVDT

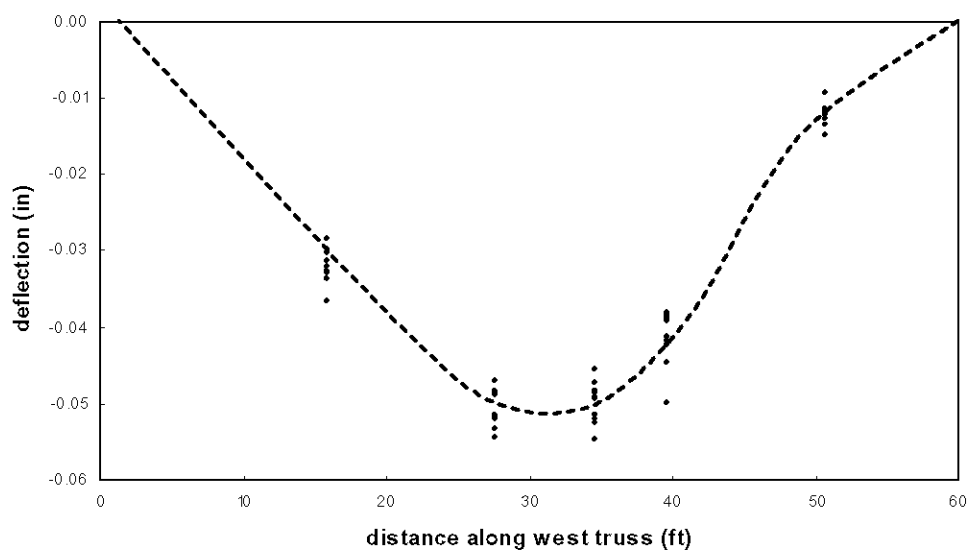
Mid-span deflections obtained from the computer model are provided in Table 3, along with the mean and standard deviation of the experimental data plotted in Figure 24.

Figure 24. Influence line for mid-span deflection as a result of live load

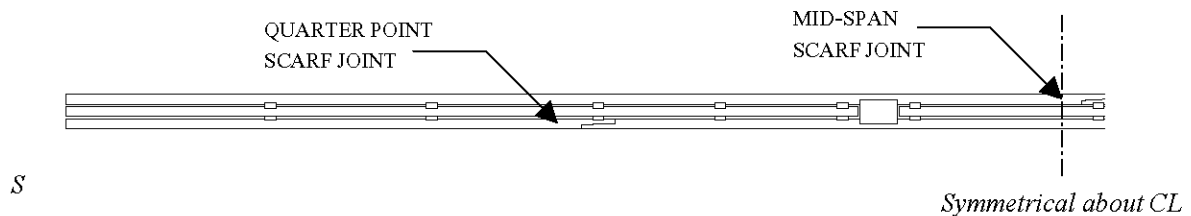
Field tests were performed using an extensometer in an attempt to determine the extent to which the scarf joints were still functioning. The scarf joints in both the interior lower chord member near the quarter point and the exterior lower chord member at mid-span were tested. The extensometer was positioned to span the top of the joint. Figure 26 is an illustration of the lower chord, showing the positions of the scarf joints. Three trials were performed for each joint location, and for each trial data was recorded with the truck at six different positions along the span: A, B, C, D, F and G (see Figure 8).

Figure 26. Plan view of southern half of lower chord showing locations of scarf joints

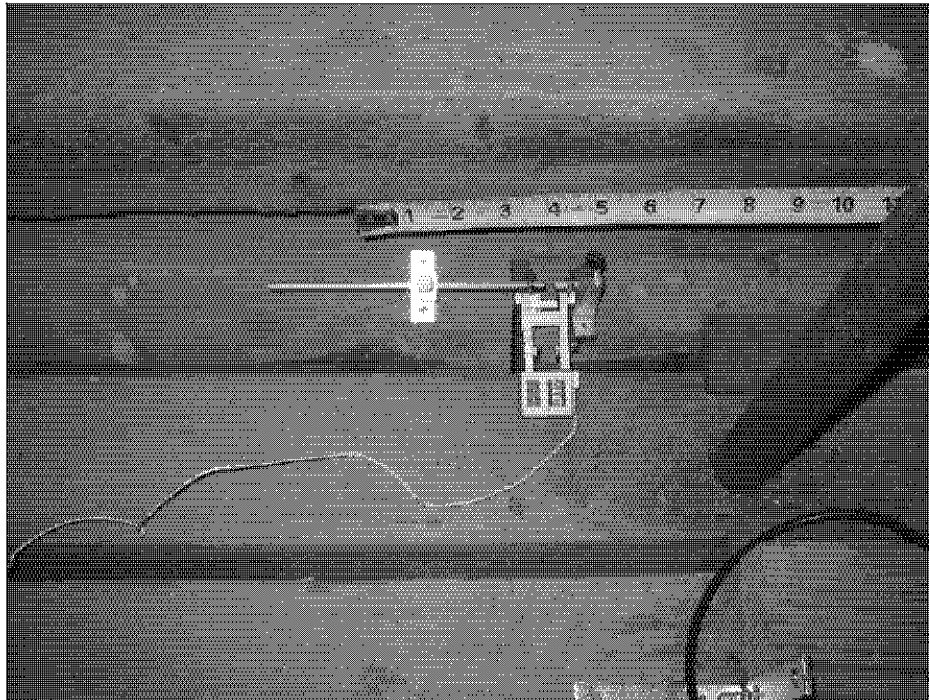
Figures 27 and 28 show the extensometers in place at the two scarf joints.

Figure 27. Extensometer spanning the scarf joint at mid-span

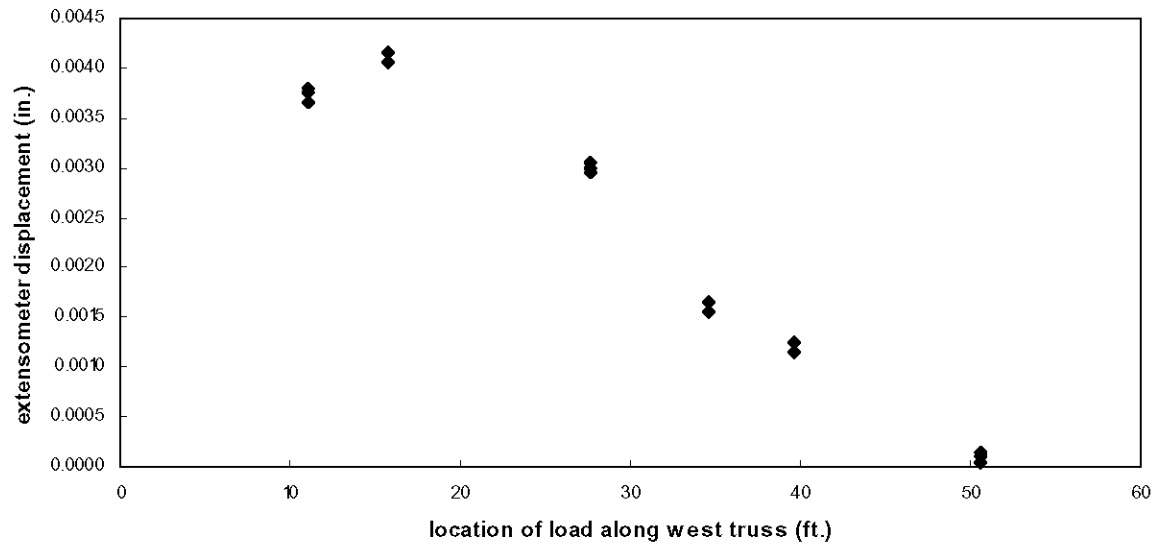
Results of the data collected from the extensometer are provided in Figures 29 and 30. For both plots, the independent axis demonstrates the location of the vehicle's center of gravity along the west truss, with zero at the south end. The movement of the scarf joint is shown on the dependent axis.

Figure 29. Results of extensometer placed at the mid-span scarf joint

Initially, it was thought that the scarf joint would act as a “pointer,” such that a positive result would indicate the two members were pointing upward (\wedge) and a negative result would indicate that they were pointing downward (\vee). According to the influence line in Figure 29, however, this would mean that the mid-span scarf joint consistently pointed up, even though the deflected shape at mid-span suggested just the opposite. Rather, it seems the results indicate that the scarf joint was not rotating at all, but was simply opening up as a result of tension in the bottom chord. Still, it is not clear why the mid-span joint would open more with the truck near the south end than it did with the truck near the north end. Nor is it clear why the scarf joint at the quarter point closed with the truck near either end of the bridge, since the bottom chord was always in tension, regardless of the truck’s position.

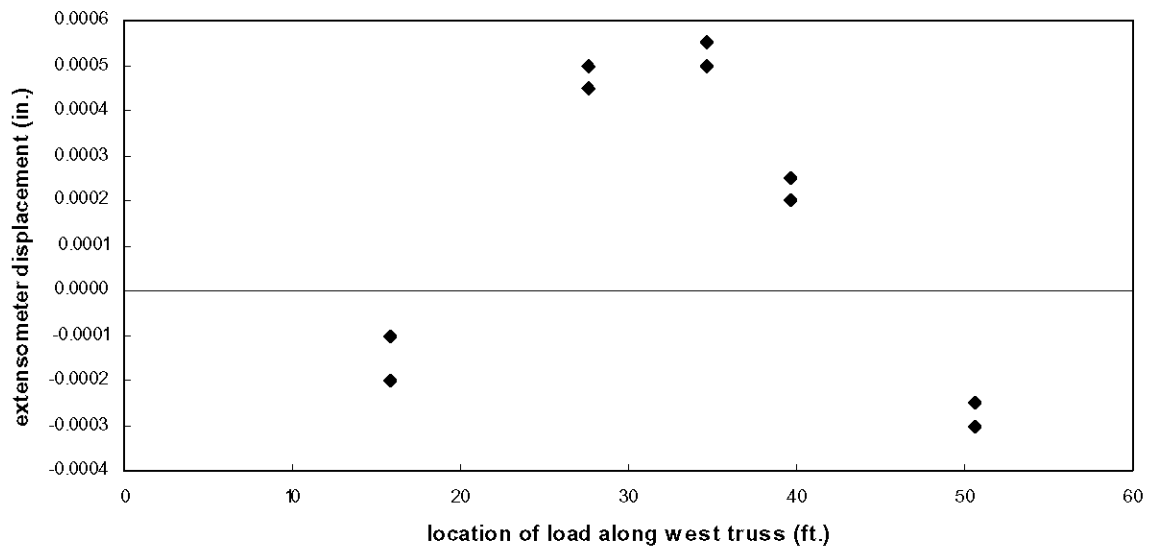
Figure 30. Results of extensometer placed at the quarter-point scarf joint

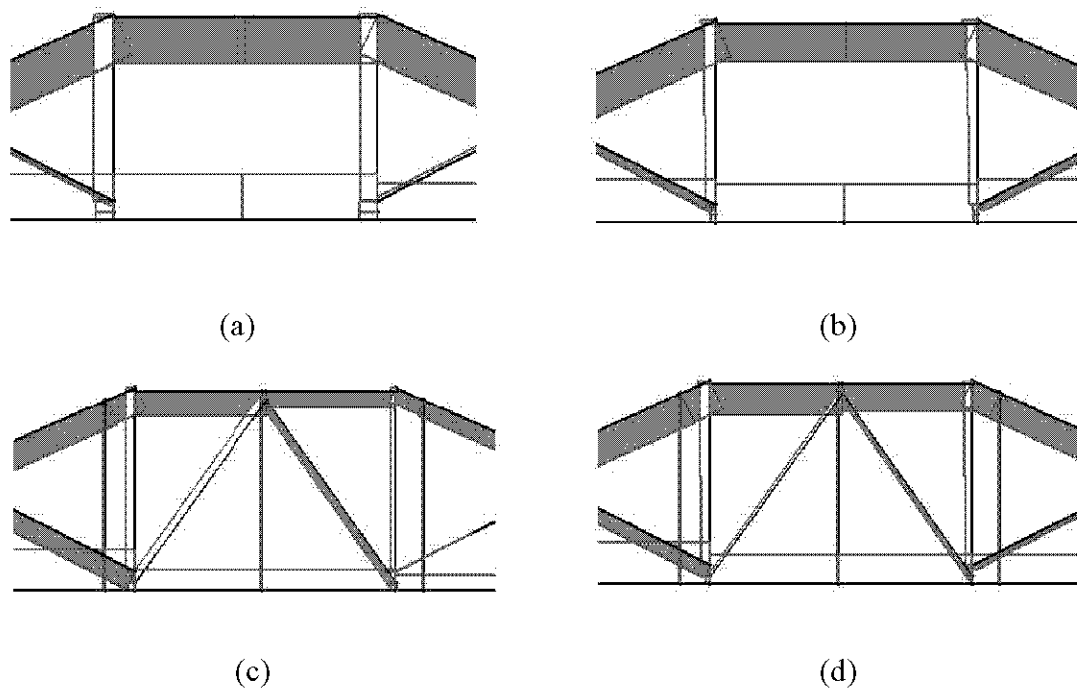
This behavior is apparent in the axial force diagrams of Figure 31. The first two diagrams show the axial forces in the original bridge, first with live load alone (Figure 31a), then with the combined dead and live load (Figure 31b). The second two diagrams show the axial forces in the existing bridge, first with live load alone (Figure 31c), then with the combination of dead and live load (Figure 31d). The live load for all four diagrams in the model was placed at location A, where the maximum effect was observed in the field (see Figure 7). Note, however, that due to the difference in the number of floor beams between the original and existing bridges, the load distribution varied between the two models.

Figure 31. Axial force diagrams for (a) live load at A in original configuration, (b) dead and live load at A in original configuration, (c) live load at A in existing configuration, and (d) dead and live load at A in existing configuration

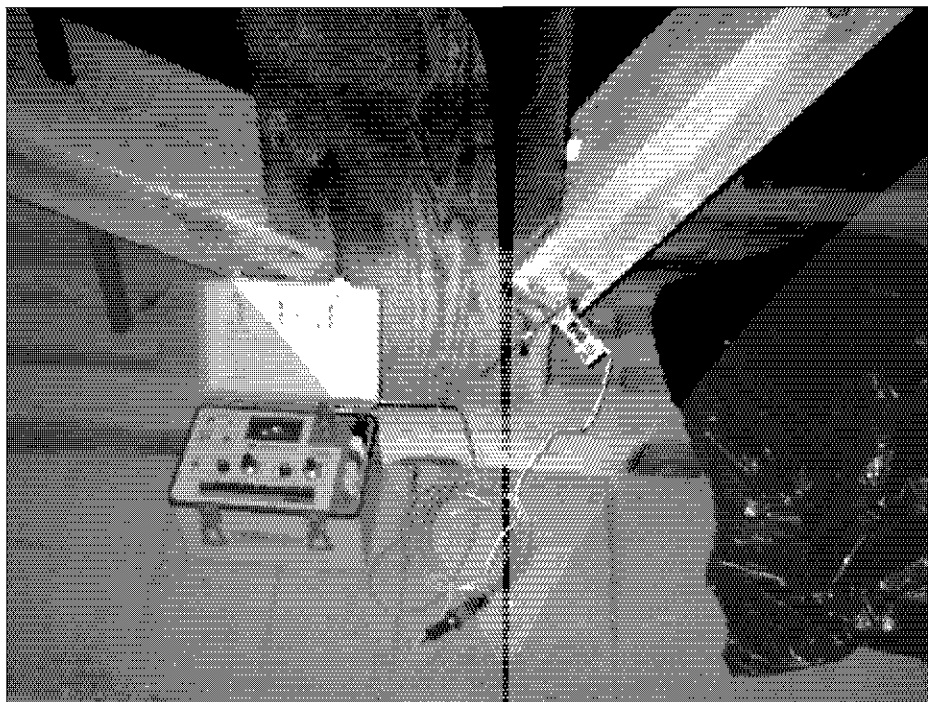
longitudinal axis of the counterbrace, spanning its connection with the queenpost (see Figure 32). Three trials were performed, stopping the vehicle at five locations along the span each time to collect data.

Figure 32. Extensometer in place at the connection

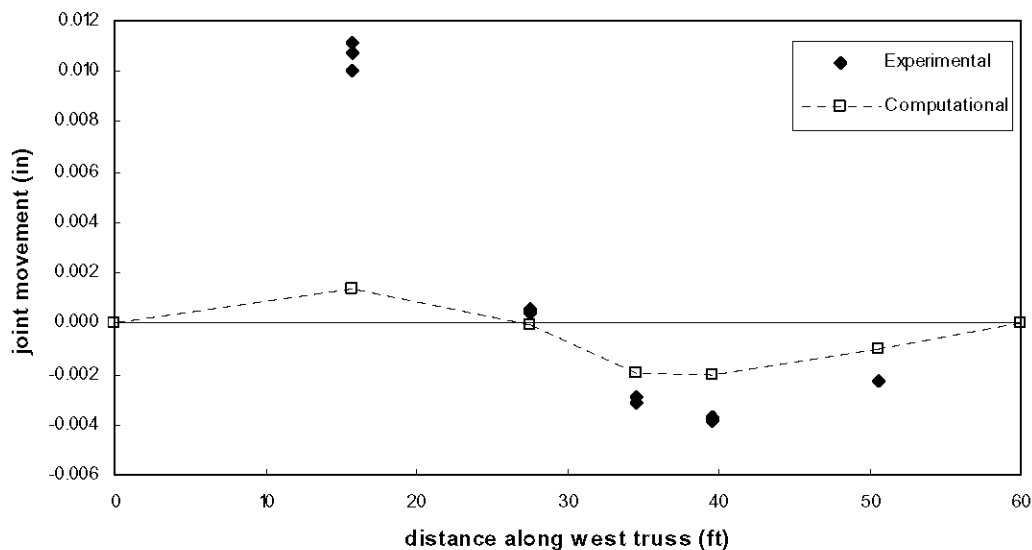
The results of the field test and computational model are shown in Table 4 and Figure 33. Table 4 provides a comparison of the observed field data with the values predicted by the computer model. Figure 33 illustrates the data with the x-axis denoting the vehicle's location along the west truss (zero represents the south end), and the y-axis showing the amount of movement recorded in the joint along the longitudinal axis of the counterbracing member. A positive movement correlates to the joint opening up due to a net tensile force, while a negative movement correlates to its closing under net compression. The dashed line provides an approximate solution of the influence line for joint movement.

While the calculated and experimental magnitudes differ, their matching trends are clearly evident in Figure 33. The greatest variation between the experimental and computational results was when the live load was very close to the south abutment. The errors in the computed values were due to the model having a pinned joint at this location instead of one that suddenly became disconnected. In the field, the extensometer was observed to widen steadily as the truck moved past the queenpost location. It was apparent from both the experimental and computational analysis that the addition of these center panel diagonals added nothing to the performance of the truss system. In fact, the bridge is doing its best to remove them!

Figure 33. Comparison of influence lines for joint movement at queenpost – counterbrace connection

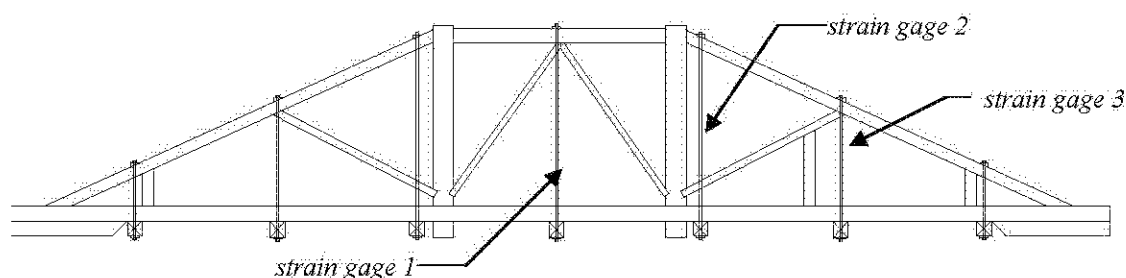
Each truss (east and west) employs seven metal rods to convey vehicular live loads from the floor beams to the truss. Two of the rods are part of the original configuration, but the rest were added as part of the 1979 rehabilitation. Without definitive information, it has been assumed throughout this study that all of these rods were made from steel. In the field, strain gages were mounted to three of them to get a better understanding of the loads they carried. The locations of the instrumented rods are illustrated in Figure 34.

Figure 34. Strain Gage Locations along West Truss

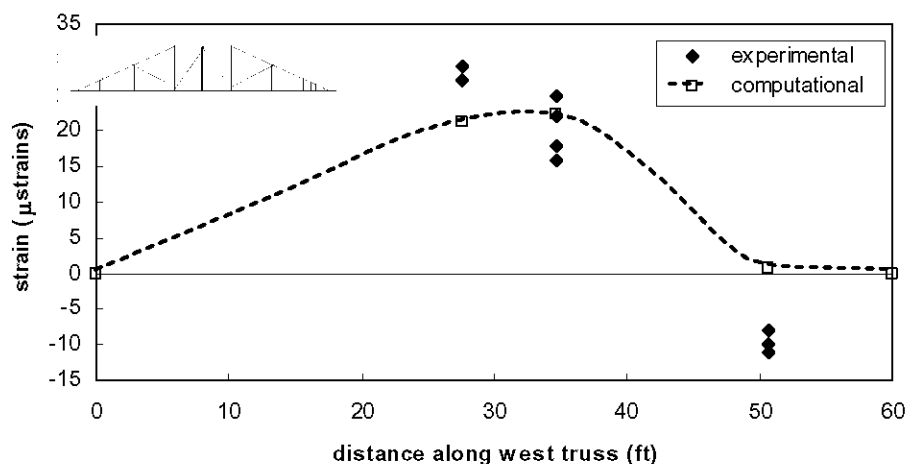
Figure 35. Influence line for strains in Rod 1

It is interesting to note the number of times a negative value crept into the results, which indicated a rod was being compressed. It was surely not the intention of either the original builders or the engineers who designed the rehabilitation for this to happen, but while the magnitudes differ, both the experimental and computational results predict such behavior. Of course the computational results could be affected by limitations on connection modeling, but in the field, the rods should be free to slide up and down through their connections to the truss members. Since the instrumentation picked up compression, the connections must be preventing this free movement.

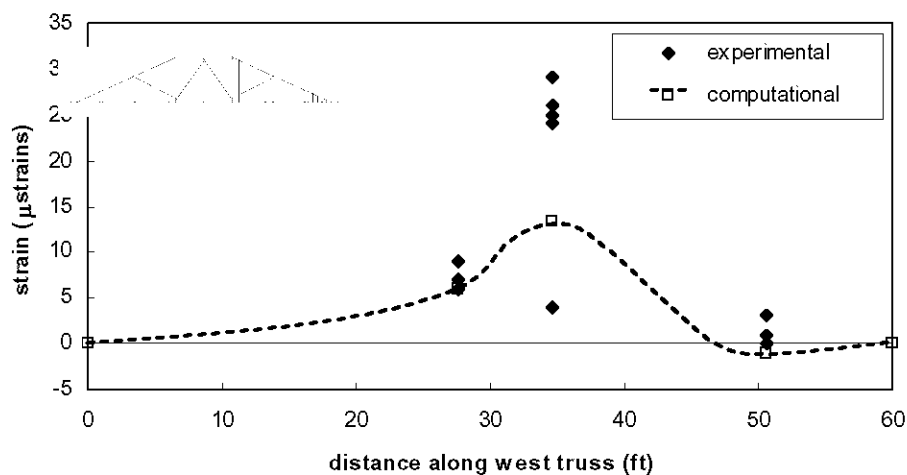
Figure 36. Influence line for strains in Rod 2

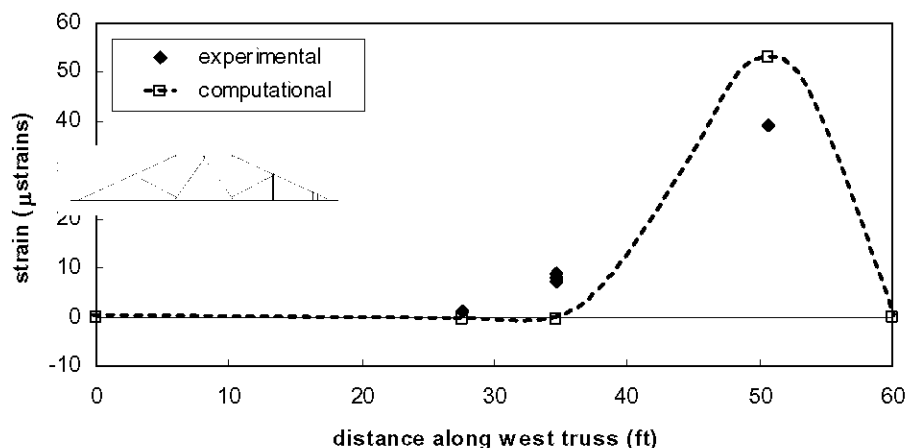
Figure 37. Influence line for strains in Rod 3

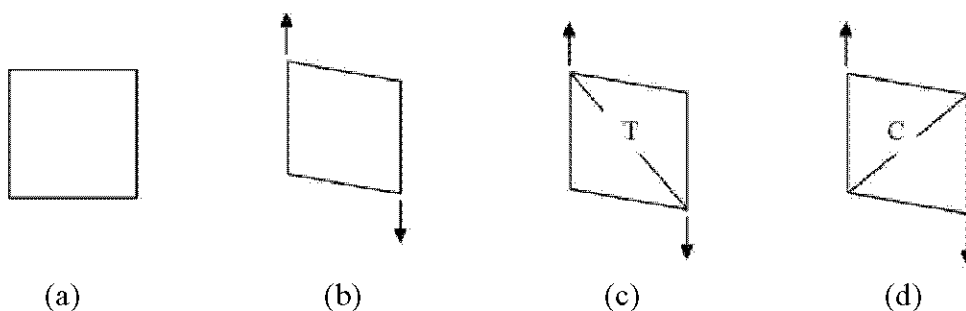
The role of the web in a steel beam is much like the role of the vertical and diagonal members between two chords of a truss. That is, they are both a means of transferring shear forces and maintaining stability in the beam or truss. Depending on the orientation of the diagonal, shear forces in a truss may be transferred through tension or compression. A simple example to describe this mechanism is a square box, shown in Figure 38a. When subjected to shear forces, the box will tend to deform as shown in (b). To resist this deformation, diagonal members may be added as shown in (c) or (d). The orientation of the diagonal member does not affect the magnitude of the force that it resists, but it does determine whether the method of resistance is tension or compression.

Figure 38. Shear force in a square truss panel

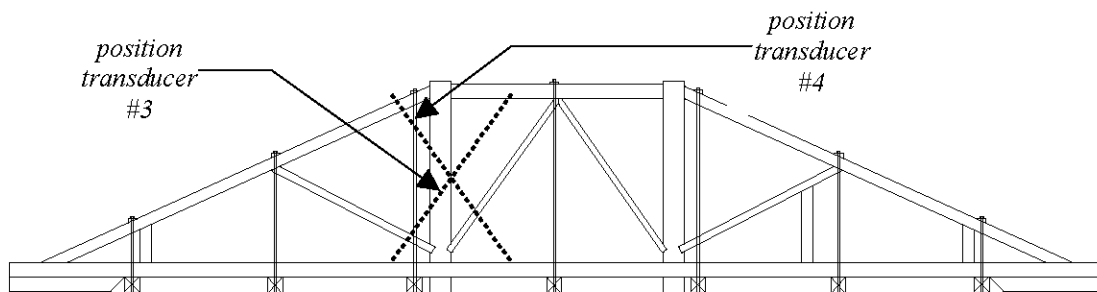
A queenpost truss like the Morgan Bridge has such a square center panel, and diagonals were added to it in the 1979 rehabilitation. To investigate the distribution of shear forces in this panel, two position transducers were arranged as shown in Figure 39. This location was chosen based on preliminary computational model results predicting the maximum deflection to be in this panel. Figure 40 shows the influence line for panel shear developed from the field test data.

Figure 39. Location of Position Transducers on the West Truss

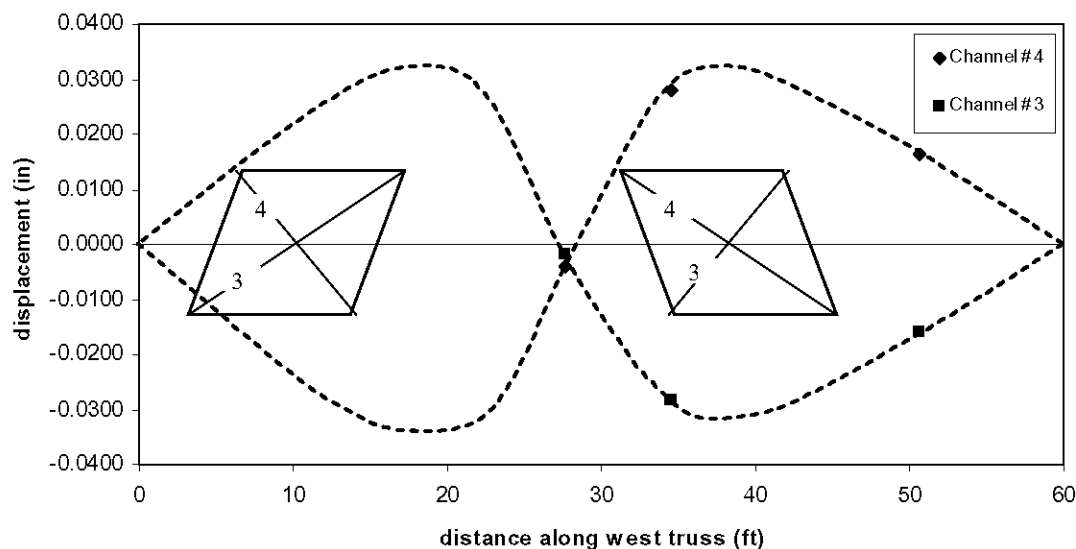
Figure 40. Influence line for panel shear

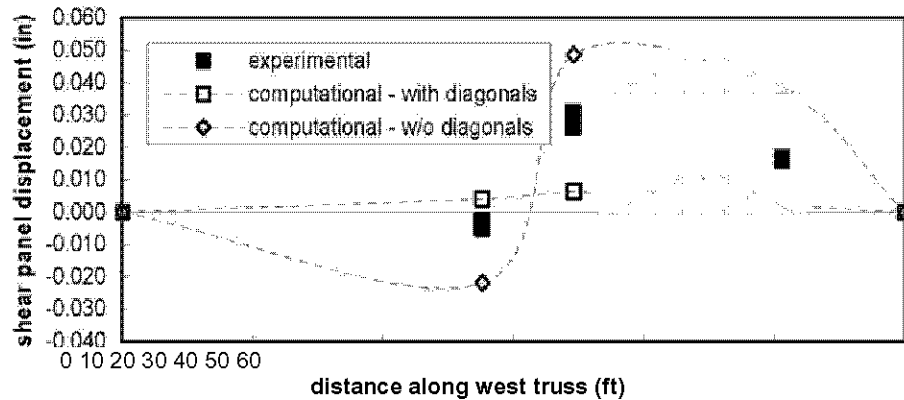
Initial comparisons of the model to the experimental results indicated that the model was too stiff with regard to panel shear deformations. The "computational – with diagonals" line in Figures 44 and 45 describes these results. It was determined that there were two possible reasons for this error in model prediction. The first is that the queenpost, to which one end of both position transducers were attached, was sharing more of the load with the adjacent steel rod than predicted. This was previously suggested as a reason for discrepancies in model prediction of strain gage results related to this rod. Another possibility is that the counterbracing diagonals in the center panel were not accurately modeled due to their cyclical loading. With different structural analysis software, it might have been possible to describe these members as gap elements (members released under tension forces), as that is what happens in a system such as this. To illustrate an "upper-bound" of the computational data in Figures 41 and 42, the deformations with both counterbracing members removed is shown with the other data. These results demonstrate that the actual effectiveness of the bridge in transferring shear forces is somewhere between these two extremes.

Figure 41. Influence line for panel shear displacement predicted compared with experimental statistical data (Position Transducer 4)

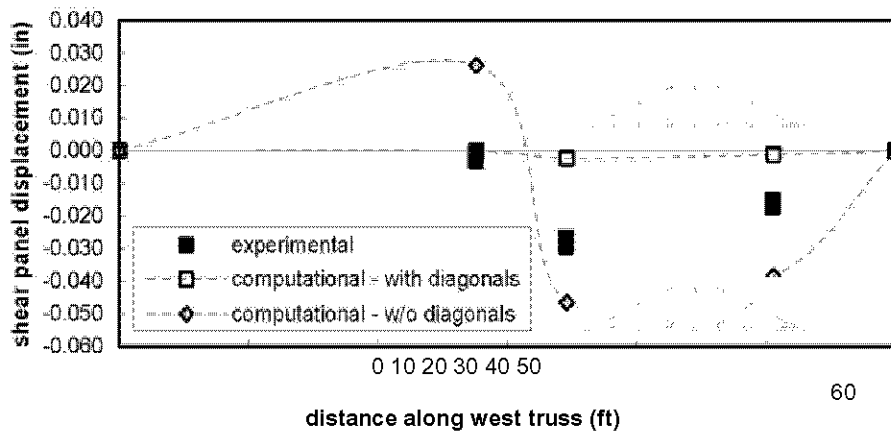
Figure 42. Influence line for panel shear displacement predicted compared with experimental statistical data (Position Transducer 3)
